School McKinley
IRN # 23721
Area East
Address 3905 Eastern Ave
 Cincinnati, OH 45226

Original Assessment (Spring 2001)

School Linwood
IRN # 21063
Area East
Address 4900 Eastern Ave
 Cincinnati, OH 45208

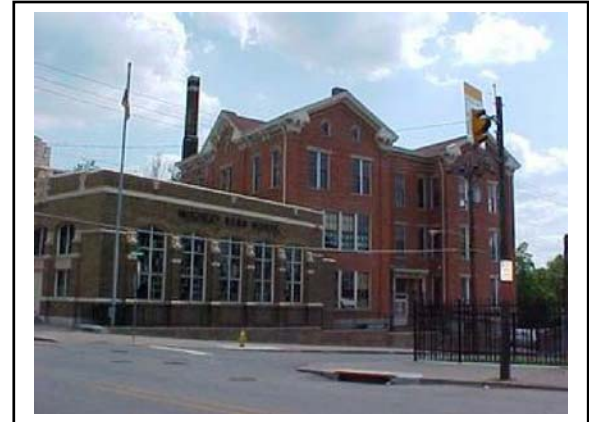
McKinley School is a four-story, 44,211 square-foot brick school building located in an urban area. The existing facility does not use modular buildings. The structure of the 1876 building is wood and concrete frame on load-bearing masonry type construction, and plaster on masonry wall construction in the interior. The floor system of the 1876 building is concrete slab on grade and wood on wood joists. The roof on the 1876 building is an asphalt shingle system installed in approximately 1986. The structure of the 1917 addition is cast concrete and load-bearing masonry type construction, and plaster on masonry wall construction in the interior. The gymnasium in the 1917 addition is wood-frame type construction. The floor system of the 1917 addition is concrete slab on grade and cast concrete. The roof of the 1917 addition is a modified bitumen system installed in 1999. The ventilation system of the building is inadequate to meet the needs of the users. The classrooms are sized to meet current standards established by the State of Ohio. A Silent Knight door contact and motion sensor type security system does exist in the school. The building does have an automatic fire-alarm system but does not have a sprinkler system. The overall building is not compliant with ADA accessibility requirements. The school is located on a 1-acre site adjacent to residential and commercial property and a railroad. The property and playgrounds are fenced for security. Access onto the site is unrestricted. Site circulation is poor. There is no dedicated space for school buses to load and unload on the site. Parking for staff, visitors and community events is inadequate. McKinley School is listed on the National Register, NR# 79002697. The original 1876 building is the oldest building currently in service in the District.

Facility Plan Recommendation	
Action	Discontinue Use
Proposed Segment	1
Proposed Enrollment	0
Proposed Grades	N/A
Estimated Project Cost (2002 Dollars)	\$300,646
Updated \$ Renovate vs. Replace	79%

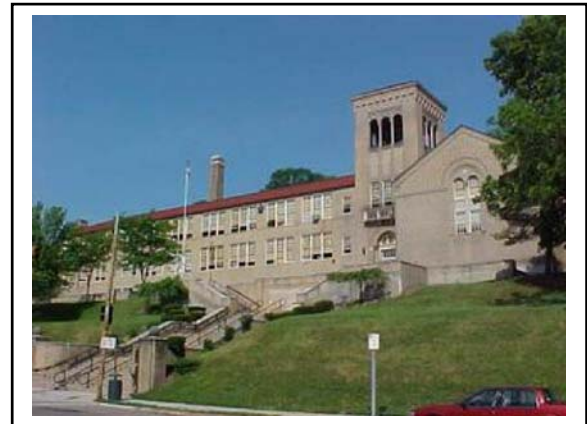
Linwood Fundamental Academy is a two-story, 35,035 square-foot brick school building located in an urban area. The existing facility does not use modular buildings. The structure of the overall facility is load-bearing masonry and concrete-frame type construction and plaster on structural tile wall construction in the interior. The floor system is slab on grade and cast concrete. The roof is a combination of low-sloped gravel surfaced built-up and a steeply pitched asphalt shingle system installed in 1994. The ventilation system of the building is inadequate to meet the needs of the users. Most classrooms are undersized to meet current standards established by the State of Ohio. A Silent Knight door contact type security system does exist in the school. The building does have an automatic fire-alarm system but does not have a sprinkler system. The overall building is not compliant with ADA accessibility requirements. The school is located on a 2-acre site adjacent to residential property and a highway. The property is partially fenced for security. The main play area is separated from a steep drop off by a brick wall. Access onto the site is unrestricted. Site circulation is poor. There is no dedicated space for school buses to load and unload on the site. Parking for staff, visitors and community events is inadequate.

Facility Plan Recommendation	
Action	Discontinue Use
Proposed Segment	2
Proposed Enrollment	0
Proposed Grades	N/A
Estimated Project Cost (2002 Dollars)	\$1,331,993
Updated % Renovate vs. Replace	89%
