School Windsor
IRN # 41764
Area Walnut Hills/Evanston
Address 937 Windsor Ave
 Cincinnati, OH 45206

Original Assessment (Spring 2001)

School Hoffman
IRN # 16519
Area Walnut Hills/Evanston
Address 3060 Durrell Ave.
 Cincinnati, OH 45207

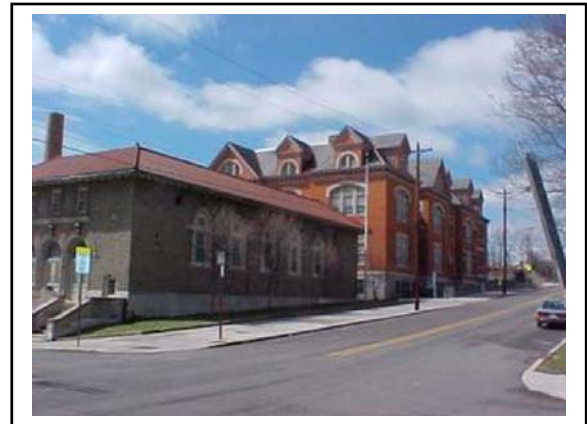
Windsor School is a two- and three-story, 50,052 square-foot, two-building brick school facility located in an urban area. The existing facility does use modular buildings. The structure of original 1888/92 building is load-bearing masonry wall and wood roof structure type construction, and masonry wall construction in the interior. The floor system is cast concrete. The roof is original slate and a single ply EPDM membrane system of unknown vintage. The structure of the 1918 annex building is load-bearing masonry with wood roof deck and steel beam type construction, and masonry wall construction in the interior. The floor system is cast concrete. The roof is original tile and gravel surface built-up and asphalt shingle of unknown vintage. The ventilation system of the overall facility is inadequate to meet the needs of the users. The classrooms are undersized to meet current standards established by the State of Ohio. A door contacts and motion sensor type security system does exist in the school. The overall facility does have an automatic fire-alarm system but does not have a sprinkler system. The overall facility is not compliant with ADA accessibility requirements. The school is located on a two-acre site adjacent to residential. The property and playground are fenced for security. Access onto the site is unrestricted. Site circulation is poor. There is no dedicated space for school buses to load and unload on the site. Parking for staff, visitors and community events is inadequate. The overall facility has some historical significance due to the age and style of the facility.

| Facility Plan Recommendation | |
|---|---|
| Action | Discontinue Use |

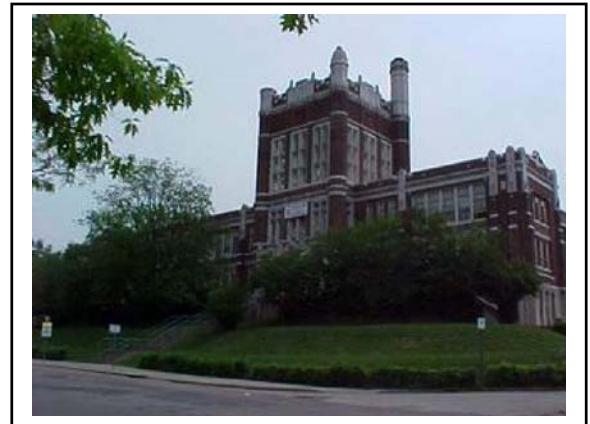
Hoffman School is a three-story, 60,152 square-foot brick, stone and terra-cotta school building located in an urban area. The existing facility does use two modular buildings. The structure of the overall facility is cast concrete on steel roof framing on load-bearing brick type construction, and plaster on structural tile wall construction in the interior. The floor system is cast concrete. The roof is an adhered EPDM membrane system installed in 1995. The ventilation system of the building is inadequate to meet the needs of the users. Some of the classrooms are undersized to meet current standards established by the State of Ohio. A Silent Knight door contact, motion sensor and security camera type security system does exist in the school. The building does have an automatic fire-alarm system but does not have a sprinkler system. The overall building is not compliant with ADA accessibility requirements. The school is located on a 5-acre site adjacent to aging residential properties. The property and playgrounds/play areas are not fenced. Access onto the site is unrestricted. Site circulation is poor. There is no dedicated space for school buses to load and unload on the site. Parking for staff, visitors and community events is inadequate. Hoffman School is listed on the National Register of Historic Places, displaying finely detailed brick, stone and terra-cotta work. The facility also has a historic auditorium/dance hall and lobby/corridor areas incorporating beautiful woodwork and plaster detailing. At the rear of the facility are a community pool and two softball fields, operated by the Cincinnati Recreation Commission (CRC).

| Facility Plan Recommendation | |
|---|---|
| Action | Discontinue Use |
