School School for Creative & Performing Arts
IRN # 68619
Area High Schools
Address 1310 Sycamore St.
 Cincinnati, OH 45210

Original Assessment (Spring 2001)

School Schiel
 IRN # 33712
 Area High Schools
 Address 2821 Vine St.
 Cincinnati, OH 45219

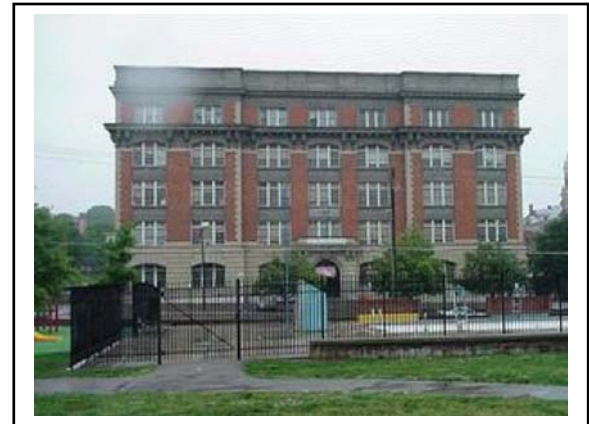
The School for Creative and Performing Arts is a five-story, 191,940 square-foot brick school building located in an urban area. The existing facility does not use modular buildings. The structure of the overall facility is brick veneer on masonry bearing-wall type construction, and mostly plastered masonry wall construction in the interior. The floor system is slab on grade on the base floor and cast-in-place concrete on the intermediate floor levels. The roof is a built-up ballasted system installed in 1999. The ventilation system of the building is inadequate to meet the needs of the users. The classrooms are varied in size, with some undersized to meet current standards established by the State of Ohio while others exceed these standards. A minimal type security system does exist in the school. The building does have an automatic fire-alarm system but does not have a sprinkler system. The overall building is not compliant with ADA accessibility requirements. The school is located on a 4.67-acre site adjacent to a residential/commercial area. The property and playgrounds/play areas are partially fenced for security. Access onto the site is unrestricted. Site circulation is very tight. There is no dedicated space for school buses to load and unload on the site. Parking for staff, visitors and community events is inadequate. The building is composed of a rough-cut limestone base. The ground floor is clad with rusticated sandstone blocks. The entrances have very ornamental sandstone decorations. The building corners have sandstone quoins. The building also has decorative terra-cotta spandrel panels and very heavily detailed terra-cotta cornice and parapet. The building is very attractive architecturally and merits any means required to preserve it. The Ohio Historical Society has SCPA listed with the National Register, as being located in the Over-the-Rhine Historic District - NR#83001985.

| Facility Plan Recommendation | |
|---|---|
| Action | New Construction/New Site |

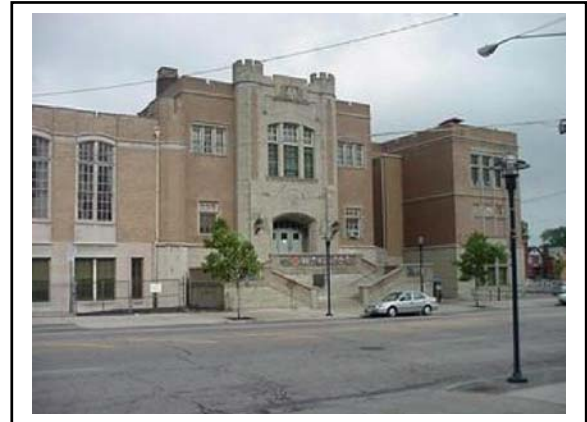
The Schiel Primary School for Arts Enrichment is a four-story (including basement), 69,648 square-foot brick school building located in an urban area. The existing facility does not use modular buildings. The structure of the overall facility is a masonry-bearing wall structure with plaster wall construction in the interior. The floor system of the base floor is slab on grade, and the construction of the intermediate floors is cast-in-place concrete. The roof is a wood structure system with a combination of built-up asphalt and modified bitumen roofing system installed before 1991. The ventilation system of the building is inadequate to meet the needs of the users. The classrooms are undersized to meet current standards established by the State of Ohio. A minimal type security system does exist in the school. The building does have an automatic fire-alarm system but does not have a sprinkler system. The overall building is not compliant with ADA accessibility requirements. The school is located on a two-acre site adjacent to residential and commercial neighborhoods. The property and playground/play areas are fenced for security. Access onto the site is restricted. Site circulation is problematic because it is located near the University of Cincinnati. There is no dedicated space for school buses to load and unload on the site. Parking for staff, visitors and community events is adequate. Water leaks have penetrated the wall behind the brick causing substantial deterioration of the brick and stone veneer. While the limestone appears to be in acceptable condition, the sandstone is generally deteriorating and should be repaired. While not an architectural gem, the building's design is attractive. Based on the drawing provided by the district and the actual walk-through, there was not a clear difference between the original building and the addition. From the exterior, the limestone work and the sandstone work could be seen distinctly.

| Facility Plan Recommendation | |
|---|---|
| Action | Discontinue Use |
